Brazil Campos Case Study: Improved Operation Efficiency and Reduced Risks by Introducing State of the Art Barnacle Mitigation Tools

Trygve Skadberg, Christian Vasbø and Rune Tønnessen, PGS

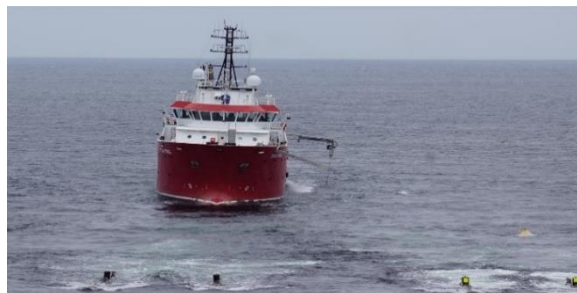
Figure 1: Support vessel positioned over the streamer front while the underwater drone is deployed.

The high-capacity seismic vessel was equipped with a pilot system for coating streamers with a proprietary anti-barnacle coating, deployed the self-propelled streamer cleaning units common to all PGS operations, and was also supported by the Thor Frigg; a large support vessel (Figure 1) equipped with a proprietary fast-going underwater drone capable of deploying the self-propelled streamer cleaners without workboat operations. Collectively, these barnacle-mitigation efforts present a unique insight into the complementary solutions necessary for remote operations in the most challenging settings.

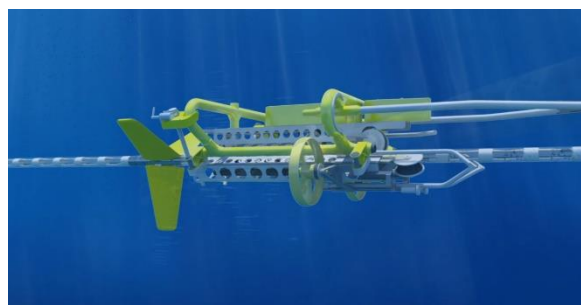
The streamer cleaning unit (SCU) shown in Figure 2 is an autonomous, self-propelled, preventive cleaning tool, adapted for streamers equipped with three lateral-steering and depth-control wings. It is used proactively for the mechanical removal of slime and barnacle larvae and was described in detail by Tønnessen *et al.* (2016). As it is most effective for early-stage small barnacle larvae, the SCU will not remove fully grown barnacles, and should be applied as a continuous preventive action before growth develops. Until recently, SCUs have been deployed from workboats only, and have proven to be a very effective barnacle mitigation tool across the fleet since 2012. The introduction of SCU significantly reduced the crew workboat exposures compared to traditional manual cleaning as the human interaction with the streamer is now limited to launch and recovery of the SCU. A series of enhancements have been developed in the decade since (Skadberg *et al.*, 2019), and several SCUs can be deployed in tandem even during data acquisition when the conditions allow workboat activity. Associated mechanical noise is temporarily restricted to local streamer positions and can be robustly removed during data processing.

Figure 2: SCU passing a three-winged bird used for streamer depth and lateral control

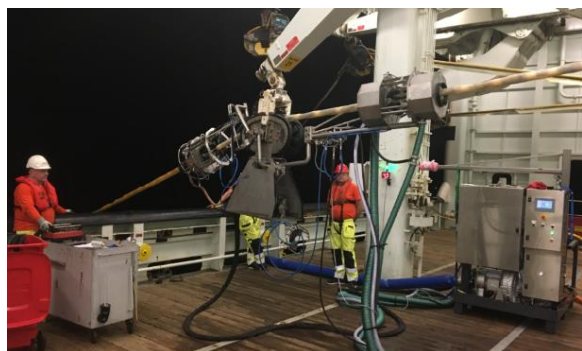
A new streamer coating system (SCS) is still under development (Figure 4) and is designed to clean and coat streamers during deployment. The coating is biodegradable and has a foul-release effect, which prevents barnacles from adhering to the streamers. The coating can be removed by mechanical scraping, where required, and both the cleaning and coating processes are designed to automatically adjust to deployment speed variations.

Figure 4: Streamer coating during deployment.

The coating slows barnacle growth but does not completely prevent it. Some experiences from testing and development are as follows:

- Coated steamer sections require about 90% less cleaning during the first 1-2 months of operations. The conditions of each survey are unique, so the time until the first required manual scraping is dependent upon the intensity of the barnacle growth.
- The coated streamers still have a foul-release effect after the first manual scraping, but the protection diminishes gradually each time the coated area is scraped.
- Barnacles are observed to be loosely attached to coated areas; meaning they are easier to remove.

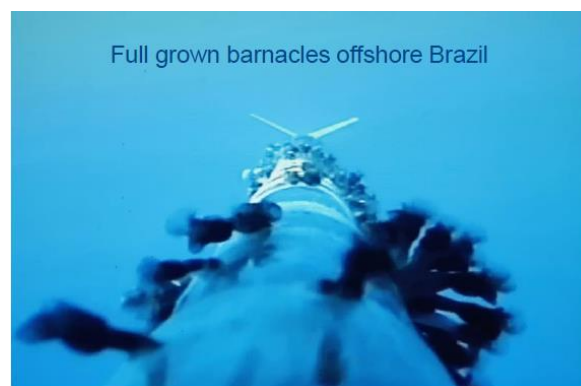
Figure 6: Underwater photo from the ROST showing advanced barnacle growth on a steamer with a three-wing steering and depth control device in the background.

The ROST was unavailable for the first 5 weeks of the survey, during which the barnacle growth accelerated, and poor weather hindered traditional workboat-based barnacle cleaning. When the ROST became available and started deploying the cleaning units on to the uncoated parts of the streamers, the crew was on the verge of recovering the entire spread as barnacle growth escalated. A full recovery, onboard cleaning and deployment would typically add 1-2 weeks to the survey time.
